**DREXEL LAKE DAM**

**BATES COUNTY, MISSOURI**

**MO 20046**

**PHASE 1 INSPECTION REPORT  
NATIONAL DAM SAFETY INSPECTION**

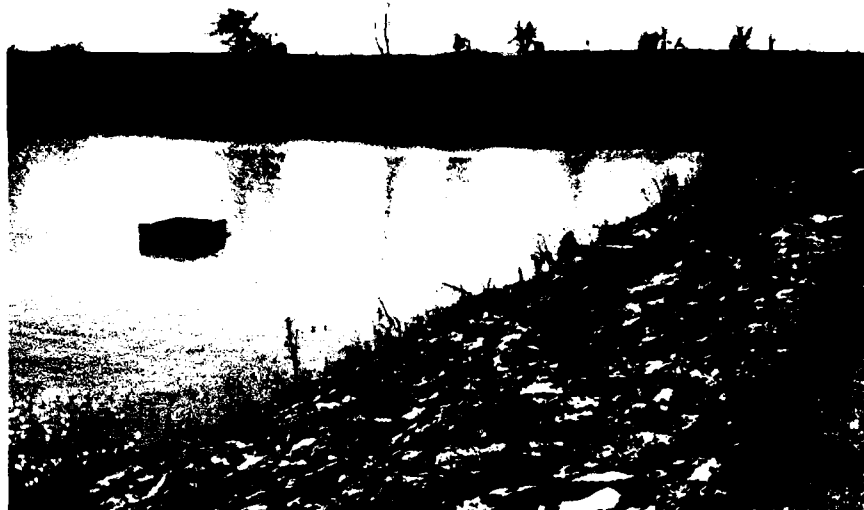
PHOTO 5: INTAKE STRUCTURE AND INFLOW PIPE

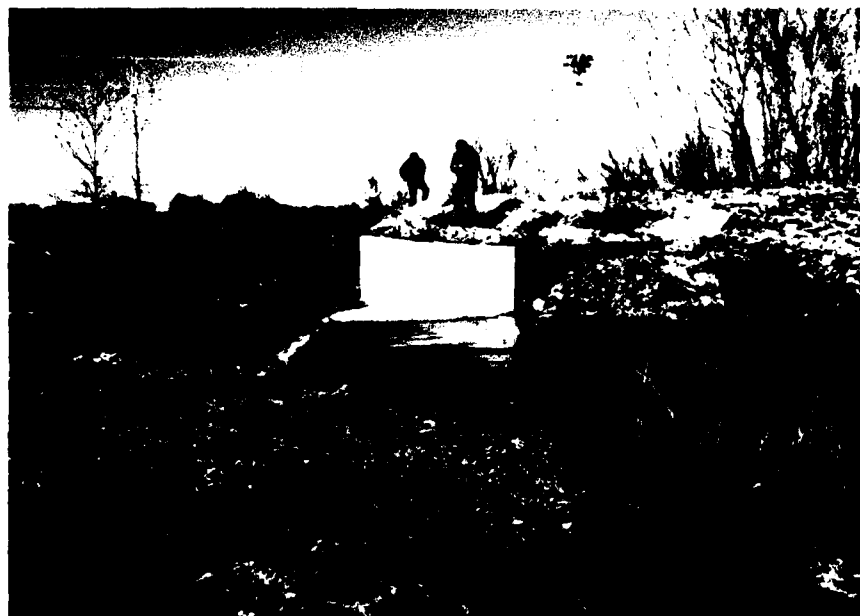
PHOTO 6: SPILLWAY CREST

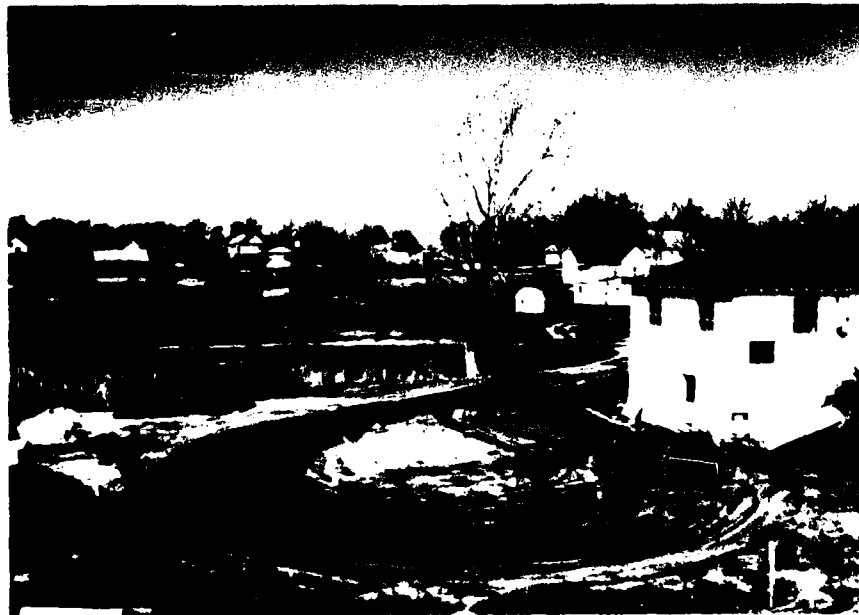
According to the St. Louis District, Corps of Engineers, the effect from rupture of the dam could extend approximately 0.5 mile downstream of the dam. There are four dwellings and the water treatment plant for the City of Drexel which could be severely damaged and lives could be lost should failure of the dam occur.

PHOTO 10: DAMAGE ZONE LOOKING DOWNSTREAM FROM DAM
